P86 Dispenser Shutter – Sensor Sensitivity

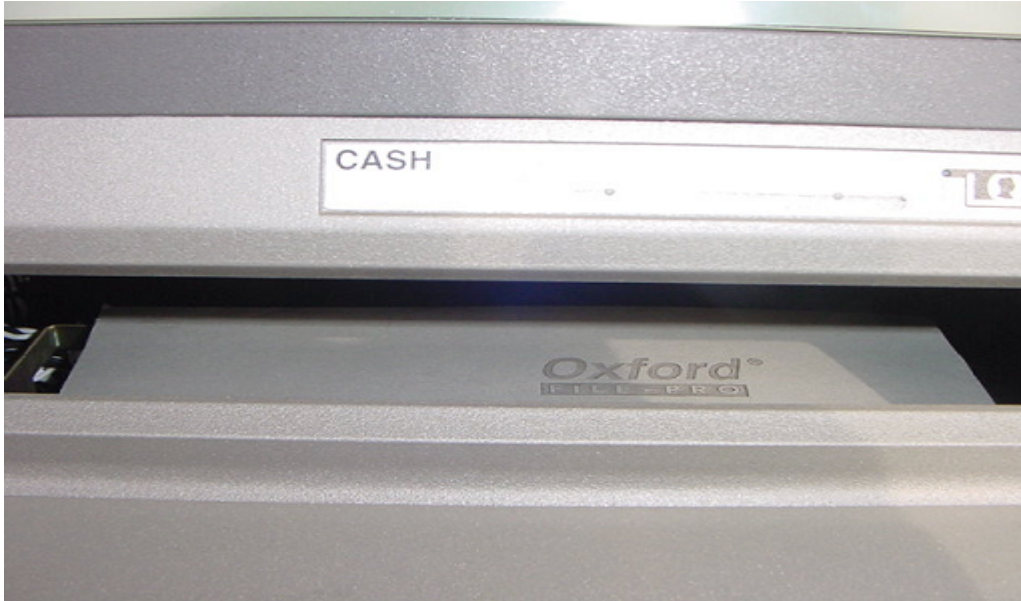
Below is a picture of the shield made for the shutter.

The shield should be made out of a very thin cardboard (1mm) and should be 192mm x 65mm in size.

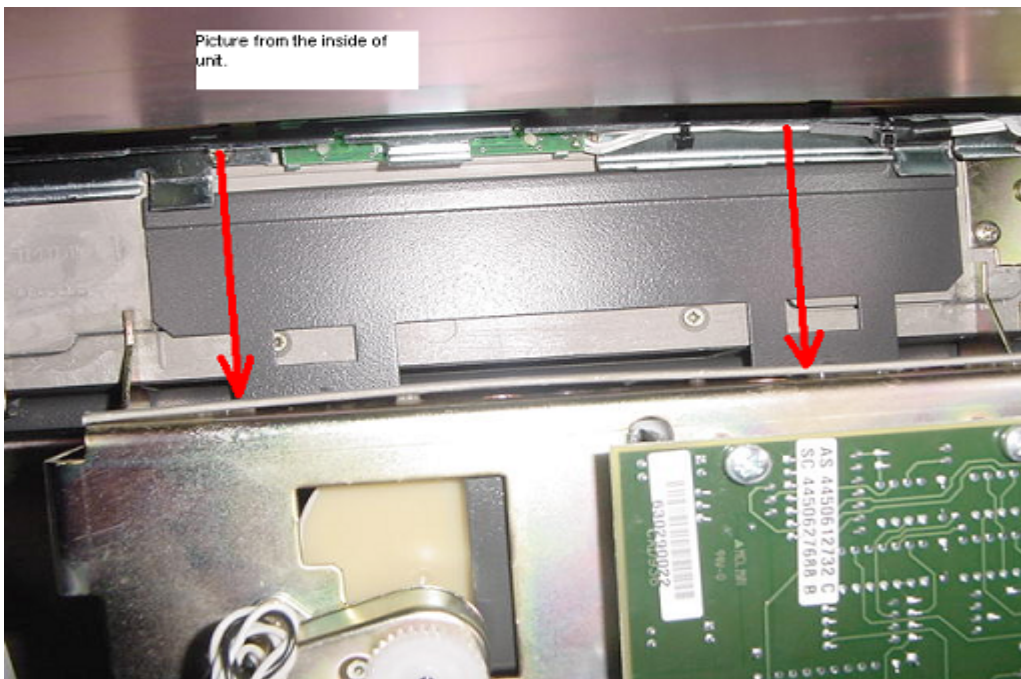
This picture is from the inside of the ATM showing the rear of the shutter and the newly installed shield.

The shield lies flat and goes towards the front of the ATM.
